Docket No. 217 – Development and Management Plan Inspection

Northeast Utilities Service Company Certificate of Environmental Compatibility and Public Need for the construction of a 345-kV electric transmission line and reconstruction of an existing 115-kV electric transmission line between Connecticut Light and Power Company's Plumtree Substation in Bethel, through the towns of Redding, Weston, and Wilton, and to the Norwalk Substation in Norwalk, Connecticut.

Date: February 4, 2004

Location: Norwalk Substation Expansion

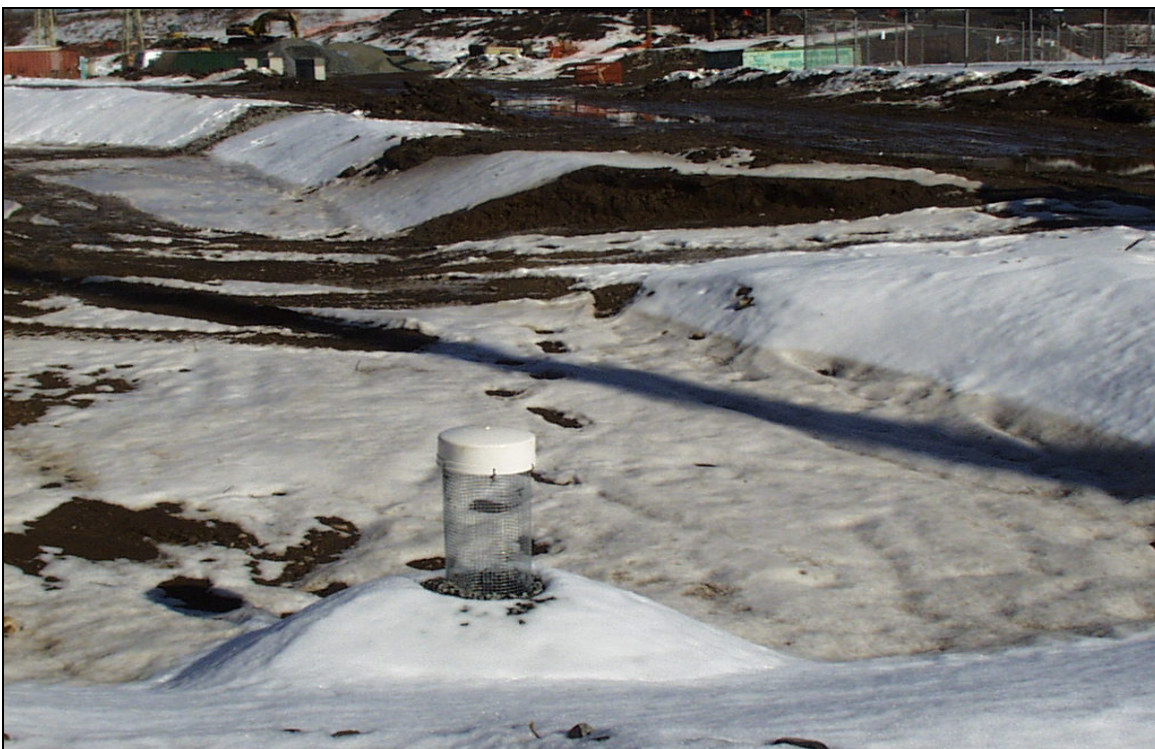
SOME AMOUNT OF THAWING HAD OCCURRED IN THE TOP SOIL LAYER WITH THE WARMER TEMPERATURES AND THE STORM. WATER HAD COLLECTED IN THE BASIN BEFORE RECHARGING 2/04/04

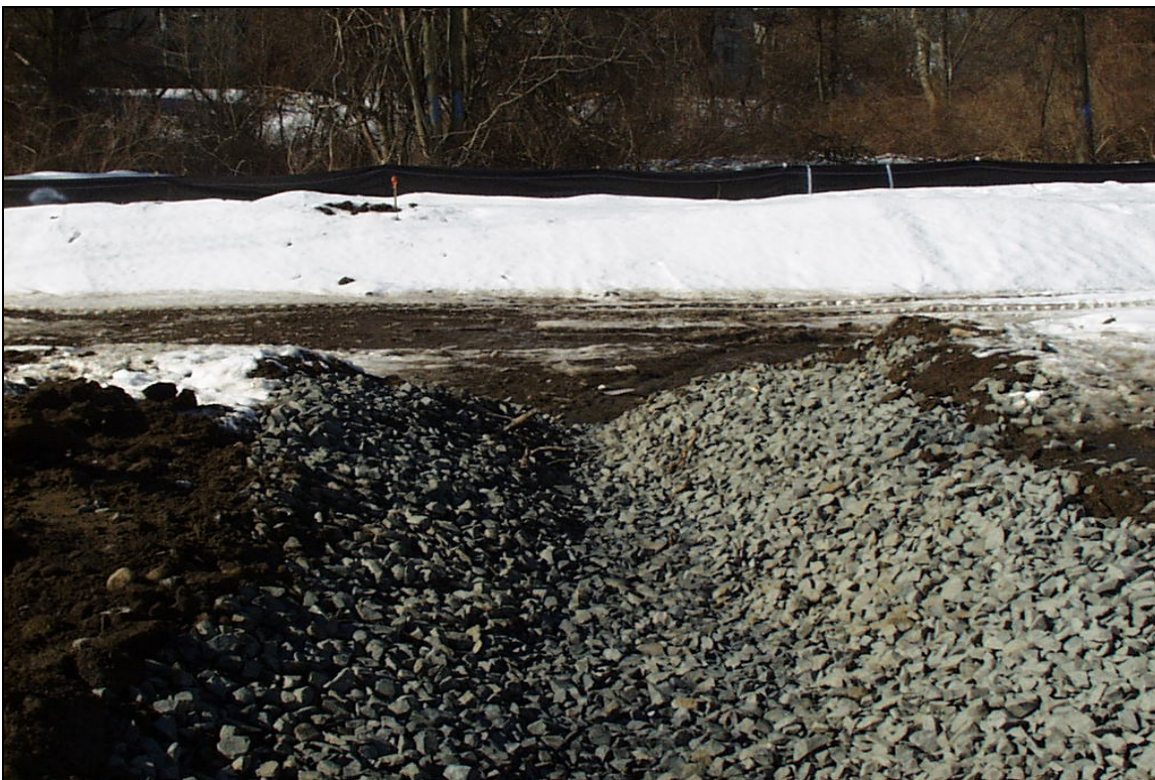
A NEW SWALE INTO THE BASIN WAS CREATED IN ORDER TO HELP BETTER CONVEY WATER ON SITE. SOME PONDING AND MUDDY CONDITIONS HAD OCCURRED AT THIS VISIT. 2/04/04

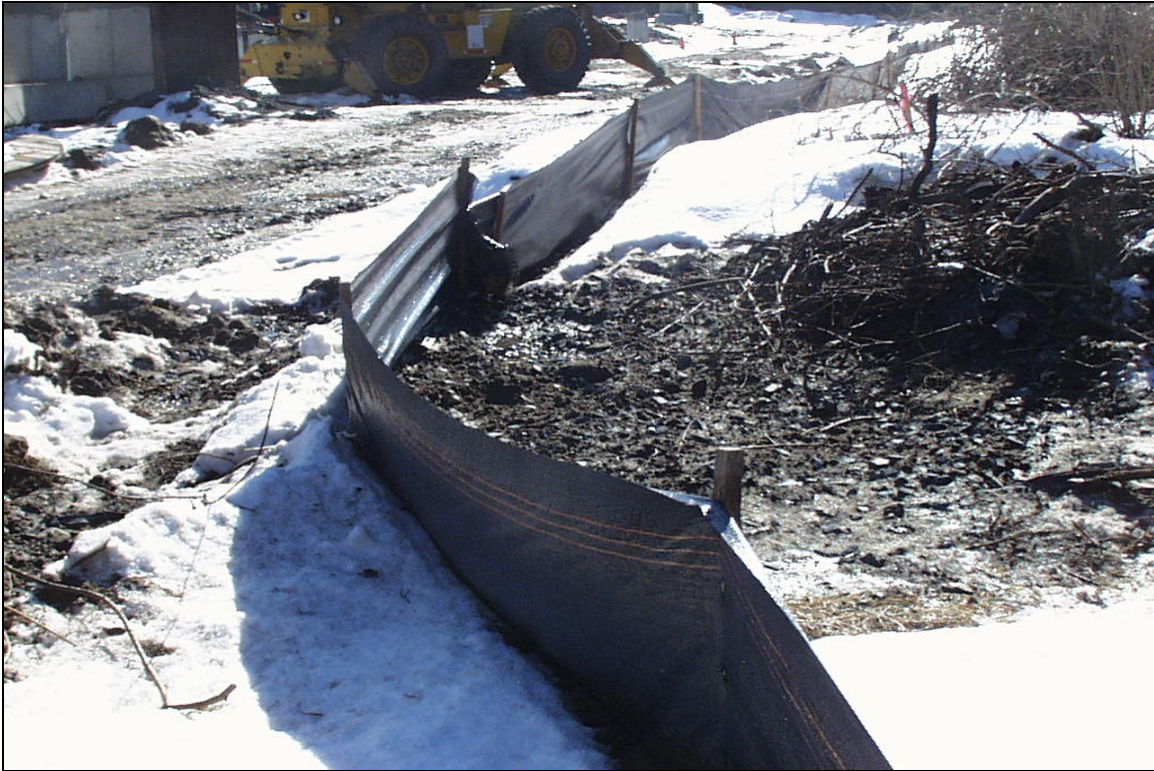
Areas of Inspection	Observation	Recommended Action
Erosion and Sediment Controls contd.	- The small pile of snow, sediment and stone placed over the silt fence last week has been placed back within the work area. 2/4/04	- No actions required at this time. Avoid placing anything from the work site beyond the silt fence. 2/4/04

THE SNOW/STONE PILE THAT HAD BEEN PLACED OVER THE SILT FENCE HAS BEEN REMOVED. THE BANK AREA WILL BE MONITORED AFTER SNOW MELT FOR EXPOSED SOIL. 2/04/04

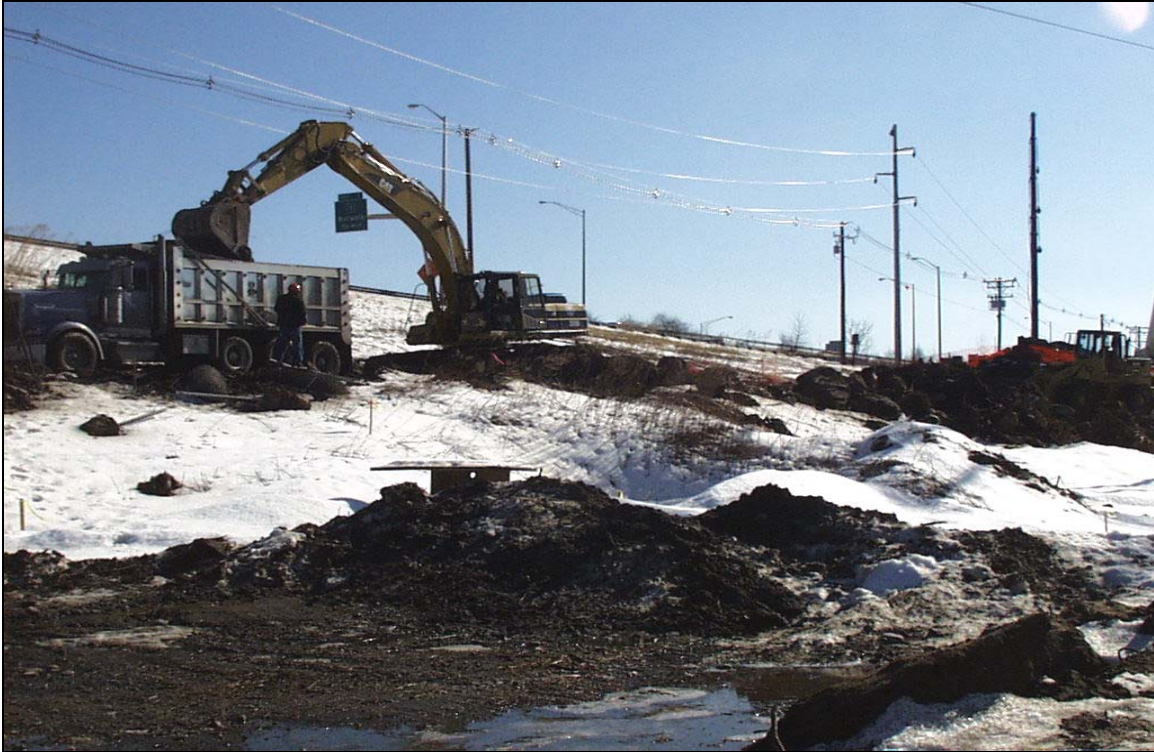
- Excavation of the non-hazardous, contaminated soil is ongoing and is now continuing along the slope. The exposed soil is a good distance from the silt fence and is under control at this time. 1/22-2/4/04 - The base of a retaining wall is being constructed in the area where excavation has been completed. 1/30-2/4/04	- None at this time. When the excavation is completed in the future, the disturbed soil will be stabilized. 1/22-2/4/04
Inland Wetland and Watercourse encroachment and mitigation	- The silt fence remains in place and there are no signs of any sediment beyond the silt fence barrier or within the river 1/22-2/4/04 - Silt fence has been repaired but may need replacement in some areas before the true thaw occurs 2/4/04	- Continue to monitor and maintain silt fence as necessary and monitor any flow from the basin outlet. 1/22-2/04/04
State species of concern, threatened and endangered species	- No species of concern are located in this area of construction.	- N/A

VIEW OF SOIL EXCAVATION AREA AS IT CONTINUES FURTHER UP ALONG THE SLOPE. 2/04/04

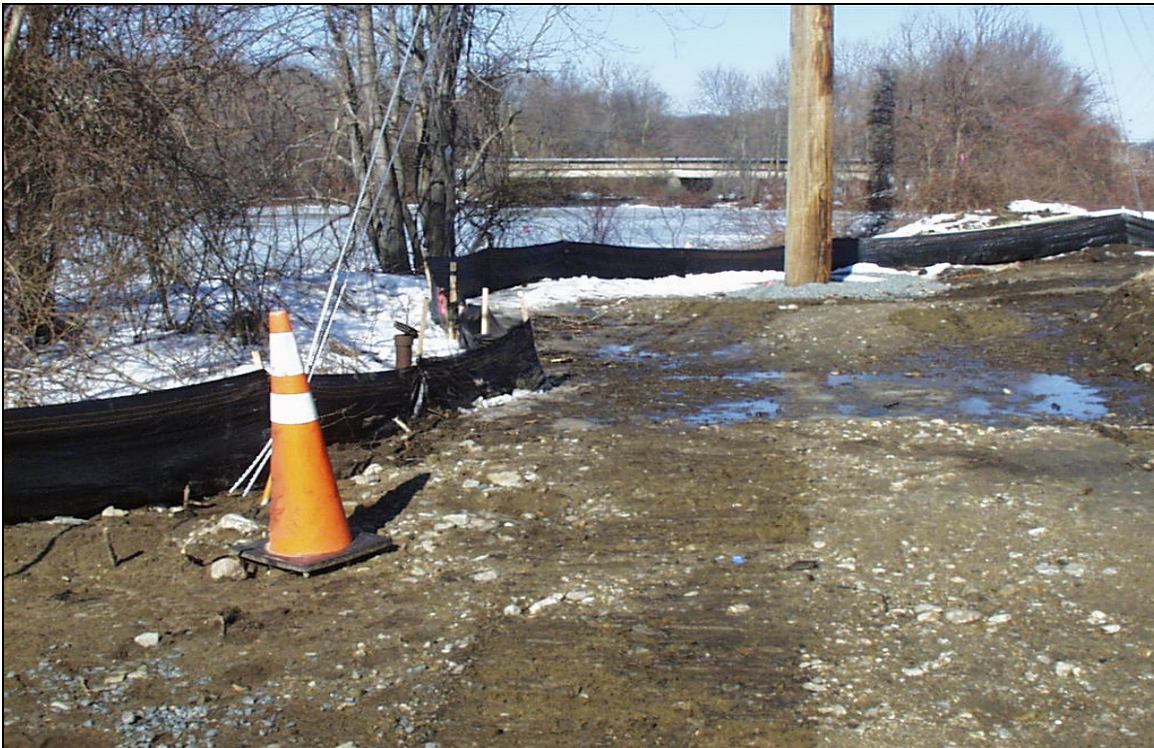
VIEW OF AREA WHERE SILT FENCE HAS BEEN MAINTAINED FOLLOWING SOME DISREPAIR NOTED LAST WEEK. 2/04/04

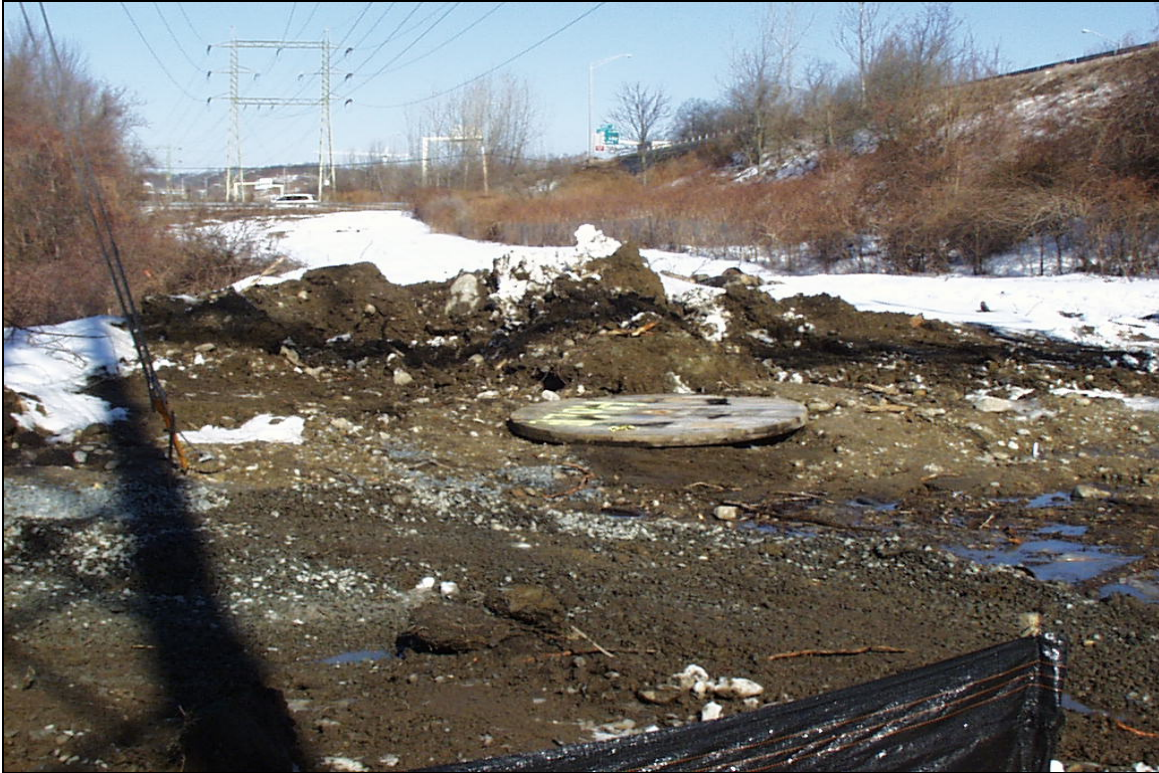
- Some piles of snow and sediment were again noted beyond the silt fence at the northern end of the work area after they had recently been graded back into place. 2/4/04	- If work needs to continue in this location, the silt fence should be extended to encompass it, otherwise, the piles should be graded back into place once again. 2/4/04

VIEW OF AREA BEYOND THE NORTHERN END OF WORK LIMITS WHERE SOIL HS BEEN PUSHED OUTSIDE OF THE SILT FENCE. IT SHOULD EITHER BE GRADED BACK WITHIN THE LIMITS OR THE SILT FENCE MUST BE EXTENDED. 2/04/04
